Report of Findings Mobile Manor, Inc.

**Inspection and Report Completed by LCM Engineering, PLLC
Karl Lorenz
Certified General Contractor
License CGC 1528366
17 March 2020**

Introduction

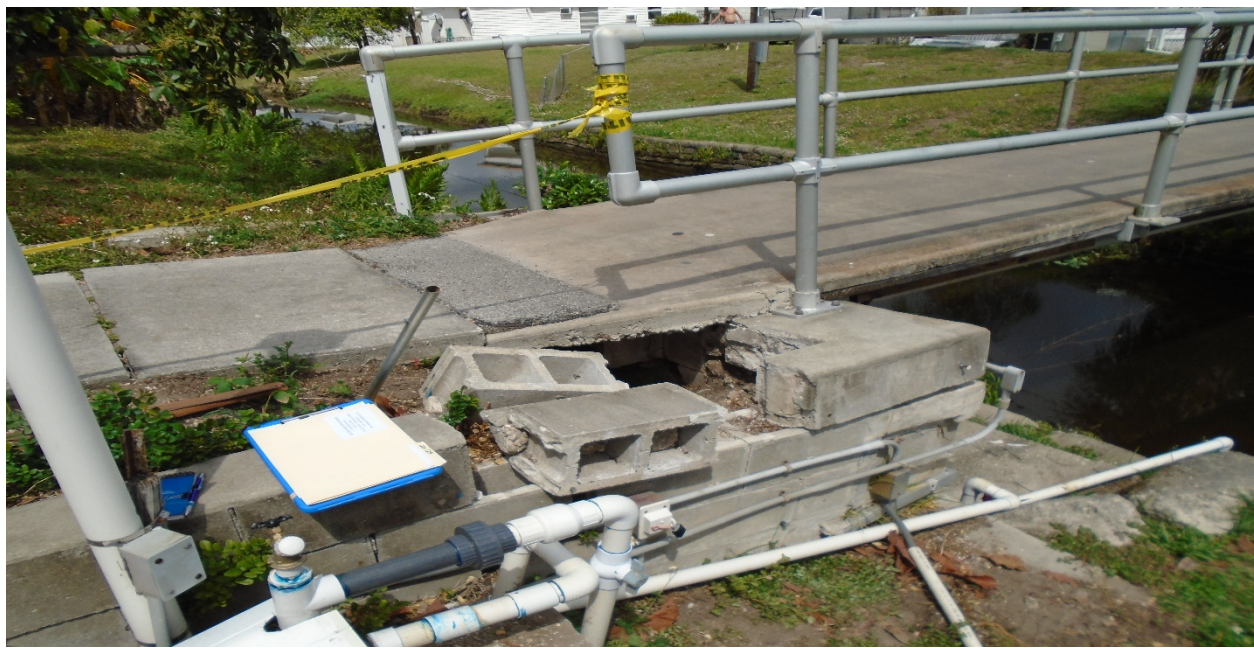
The primary construction is prefabricated and pre-stressed concrete. However, it was readily apparent that over time, several repairs were attempted to support the foot bridge. There was evidence present that prior repairs using pressure treated wood were attempted. Since golf carts are also used to cross the foot bridge, their use has contributed to the damage present. During the inspection, visible signs of pending failure were also observed.

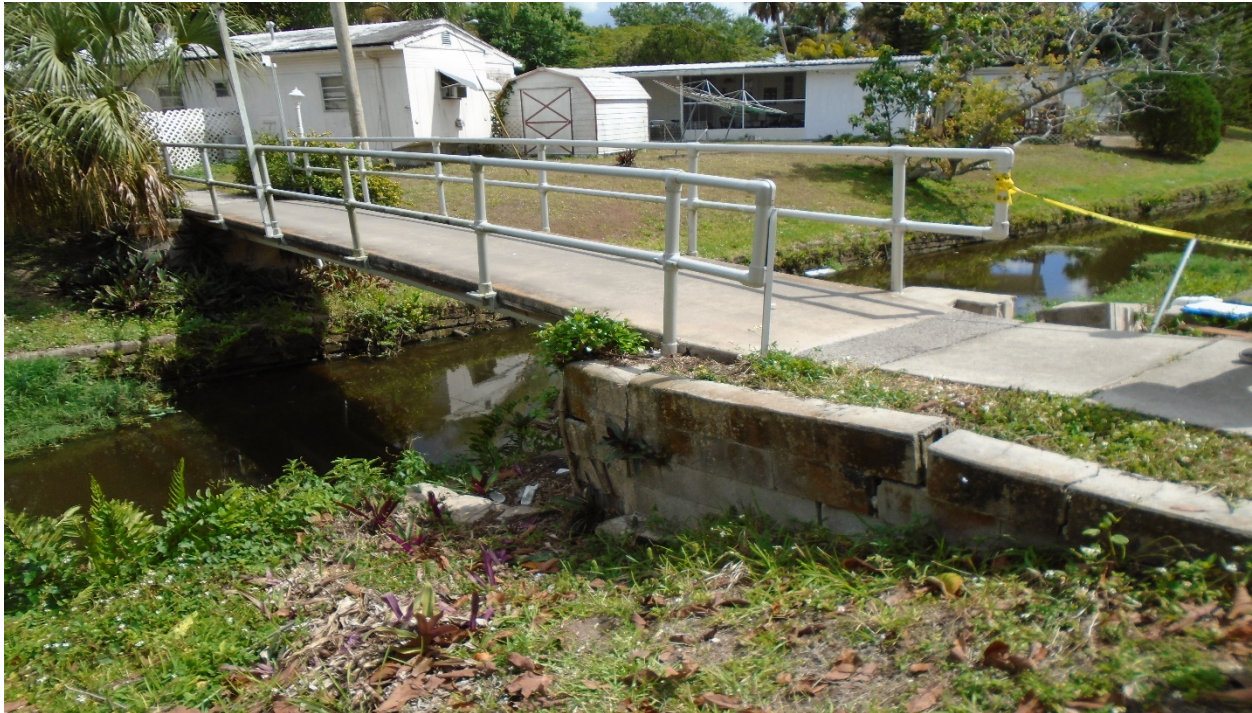
The attachment points of the bridge to solid ground are failing, causing the foot bridge to move under pressure as can be seen in the above photograph. The entire structure has moved approximately 1-2 feet over time, causing separation of the concrete blocks (CMU) and any soil contained within to slip as well. This is visible on both sides of the foot bridge. In addition, there were visible cracks in the prefabricated concrete beams supporting the foot bridge. This is another area of potential failure which can occur at any time. Stresses in the pre-stressed steel cables contained within the concrete beams can cause the concrete beams to fail without any further signs. Due to these reasons, LCM Engineering PLLC, is under the opinion that the foot bridge is unsafe for pedestrian and vehicular traffic. The pre-stressed steel cable can fail at any time, possibly causing the foot bridge to collapse even without any additional loads. The foot bridge no longer has support from the embankments as these have also separated over time. The additional stresses put on the concrete and supports from golf carts will only expedite the failure of the bridge. The failure of the bridge can occur at any time without notice, especially if the pre-stressed cables break and fail.

Due to the present condition of the pedestrian foot bridge, LCM Engineering PLLC, deems the foot bridge to be **UNSAFE** for both foot and any vehicular traffic. The condition of the foot bridge poses a significant hazard to human safety and all access should be stopped immediately.

It is also the recommendation of LCM that the current bridge be removed and replaced if desired by the community. It will be necessary for the contractor to be water certified, such as those who repair or replace seawalls due to the fact that the foot bridge crosses a small canal/stream.

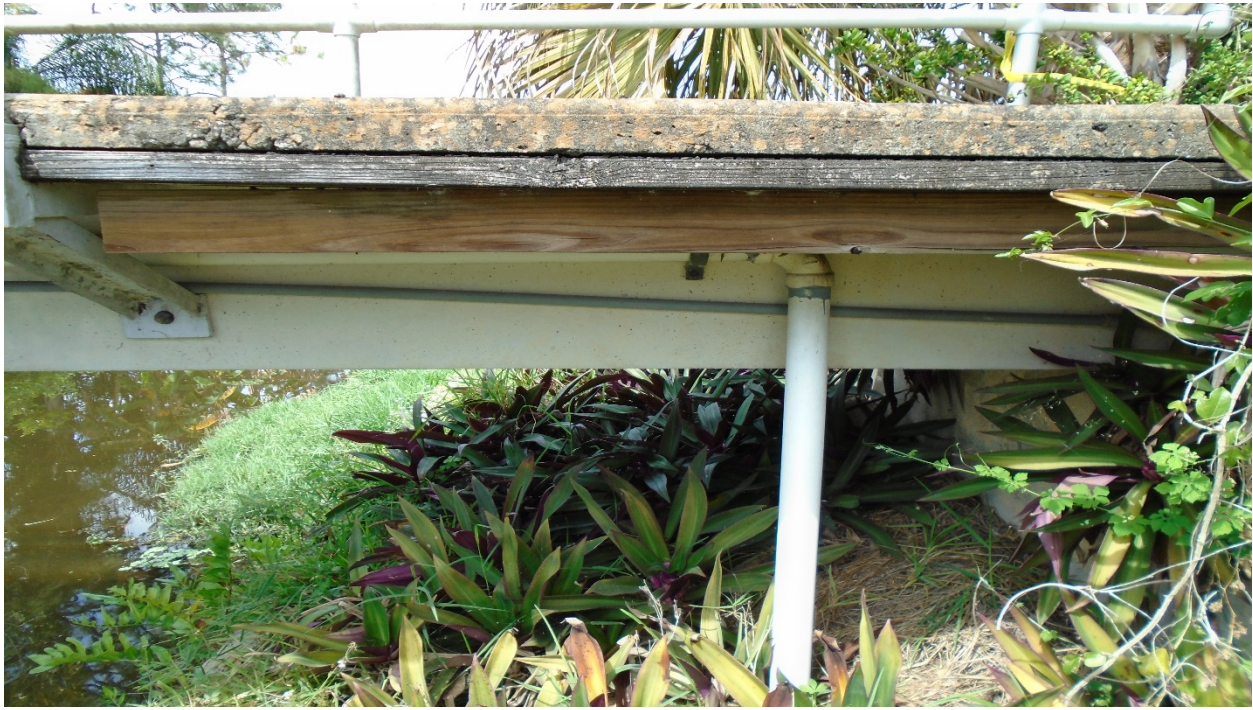
Photo depicting attempted repairs for support of bridge

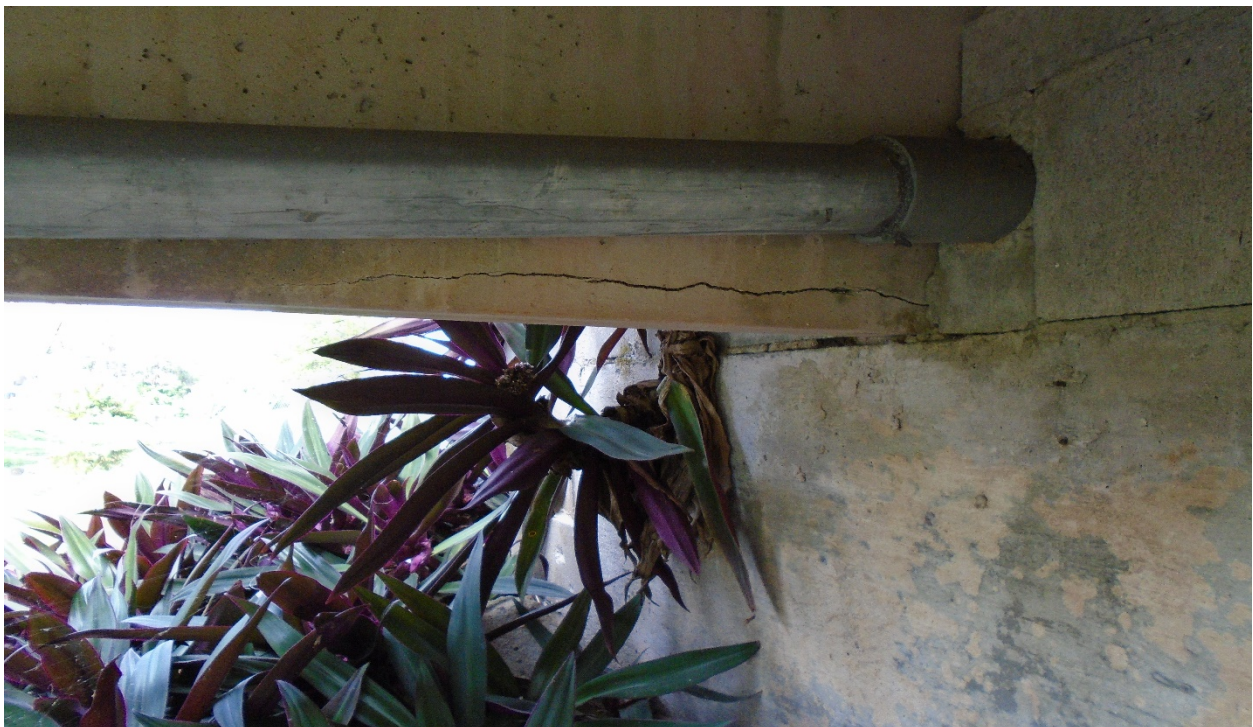
Significant cracks is concrete supporting beam

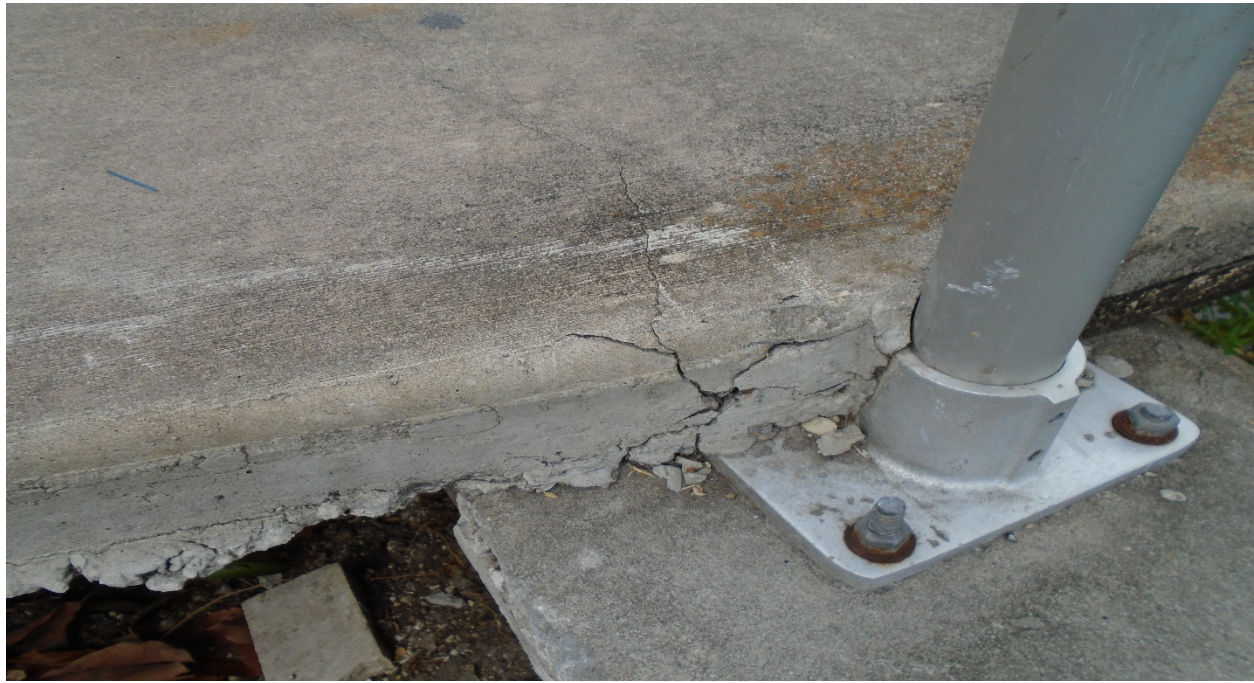
Significant cracks present in concrete slab
